NATIONAL ADVISORY COMMITTEE
FOR AERONAUTICS

REPORT No. 248

THE CORROSION OF MAGNESIUM AND OF THE
MAGNESIUM ALUMINUM ALLOYS
CONTAINING MANGANESE

By J. A. BOYER
American Magnesium Corporation

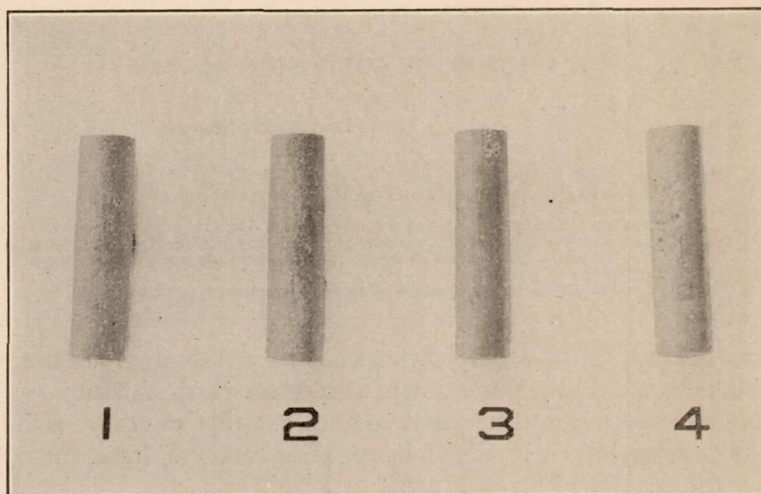
FIG. 1.—Machined pieces of magnesium after two months' immersion in salt solution. Specimens 1 and 2 immersed in 2 per cent NaCl solution. Specimens 3 and 4 immersed in 10 per cent NaCl solution

Corrosion tests of more than 50 specimens of magnesium ingot taken at random from stock have shown that pure magnesium is quite resistant to corrosion. Machined specimens immersed in salt solutions of various concentrations for a period of two months remained intact and usually showed very little pitting. Four pieces of magnesium after two months' immersion in salt solution are shown in Figure 1. The specimens were acid cleaned after removal from the corroding medium.

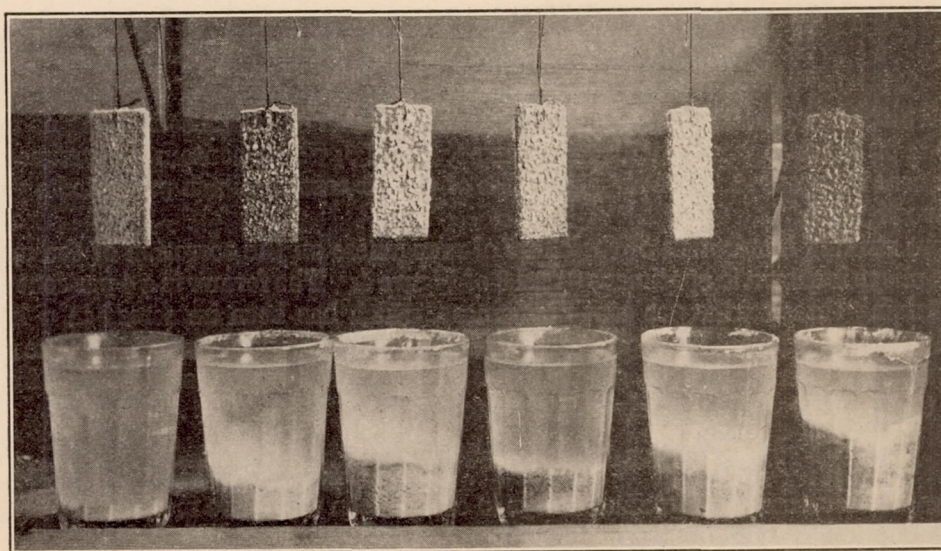
FIG. 2.—From left to right, 2, 3, 4, 5, 6, and 8 per cent aluminum, intermittent immersion, 2 per cent NaCl solution, 48 hours

With the addition of aluminum to magnesium the rate of corrosion increases enormously. A 4 per cent alloy of even half-inch thickness will be completely disintegrated in less than a week; the 8 per cent alloy corrodes even more rapidly. The effect of aluminum on corrosion is shown in Figure 2, which represents the result of a 48-hour intermittent immersion test, using 2 per cent sodium chloride solution.

As this loss in weight occurred in only 48 hours, the accelerated nature of the intermittent immersion test is evident.

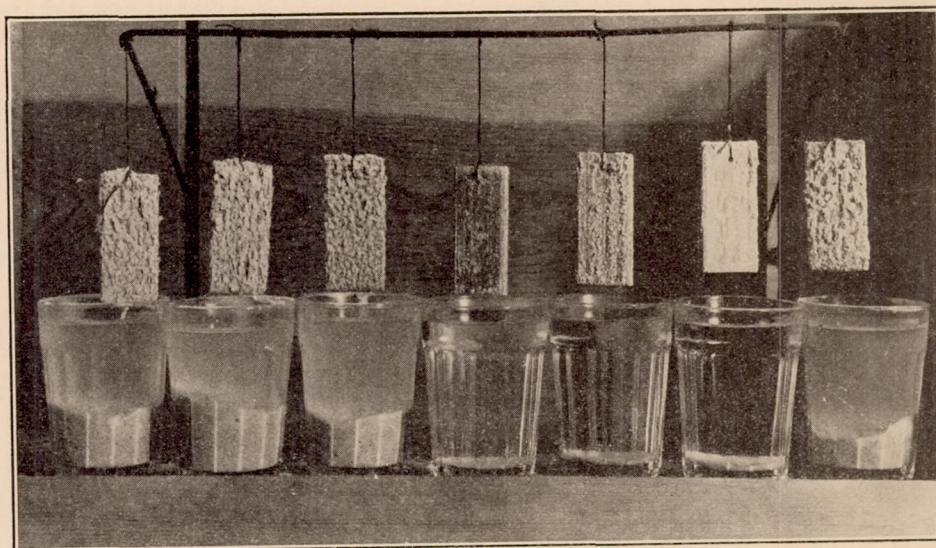
FIG. 3.—Specimens from left to right are numbers 1 to 7 of preceding table

It will be observed that the loss in weight of the aluminum alloys containing no manganese is from 20 to 30 times as great as with specimens 4, 5, and 6, which contain approximately three-tenths per cent manganese. The abnormal loss of the air cast specimen presented a problem for further investigation.

The alloy chosen was specimen No. 7 of the corrosion test shown in Figures 3 and 4. This alloy differed from the three resistant test specimens by being chill cast while the others were cooled fairly slowly; it was also air cast and contained included films, while the resistant alloys were vacuum cast; in addition, it was slightly low in manganese. It was believed that the examination to determine whether coring was the cause of corrosion would also determine the influence of the other two factors by a process of elimination.

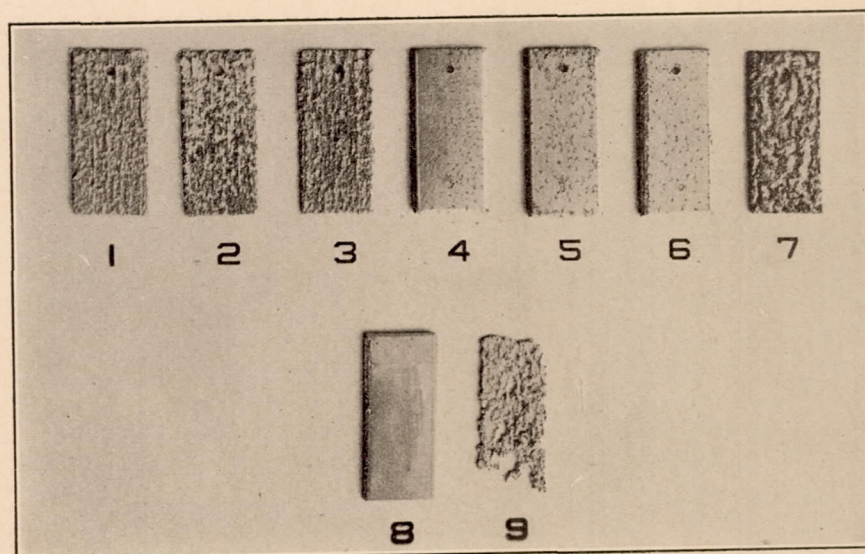
FIG. 4.—Specimens 1-7, same test as in Figure 3. Specimen 8, 4 per cent Al, 3 per cent Mn, and 9, 4 per cent Al in 10 per cent salt solution four days

A more striking illustration of the effect of manganese on the corrosion of the magnesium-aluminum alloys is shown in specimens 8 and 9 of Figure 4. The former is a 4 per cent aluminum alloy containing three-tenths per cent manganese, which has been immersed in a 10 per cent salt solution for four days. The specimen is scarcely pitted. Specimen No. 9 of the same composition except for the manganese, and immersed in the same strength salt solution for the same length of time, is almost completely disintegrated.

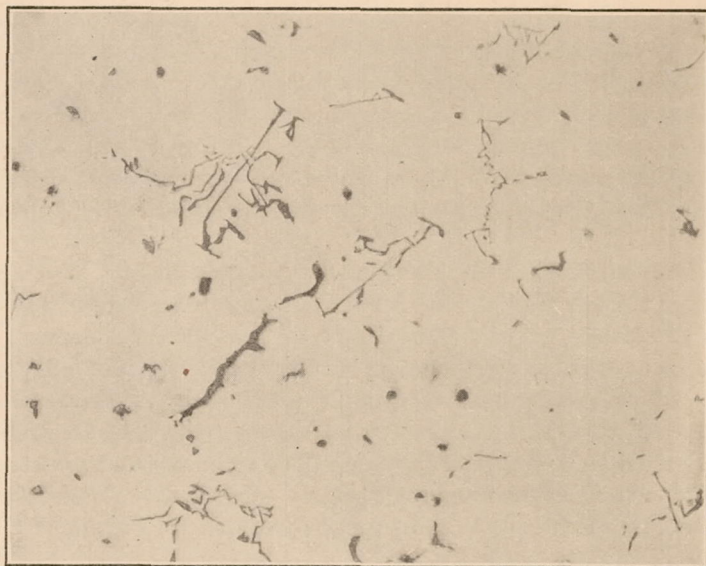
FIG. 5.—Mag. 100 \times . Microstructure of an alloy fairly resistant to corrosion

Figure 5 shows the microstructure of an alloy which was comparatively resistant to corrosion. A considerable quantity of magnesium silicide was present and also a large number of small hard particles not definitely identified. These hard particles are usually present in the aluminum alloys and are believed to be due to iron.

The microstructure of the alloys varied between that shown in Figure 5 and that of Figure 6. Silicide and aluminum constituents were present, usually in small amounts, and under the microscope these constituents were found to be absolutely inactive. The hard particles in Figure 6 which were scattered through the alloys were also inactive unless the cathode areas might possibly be an occasional one of these particles. However, if such was the case it is estimated that not more than one out of fifty or a hundred were active. During the examination of these alloys literally thousands of these particles have been observed from which no hydrogen was liberated.

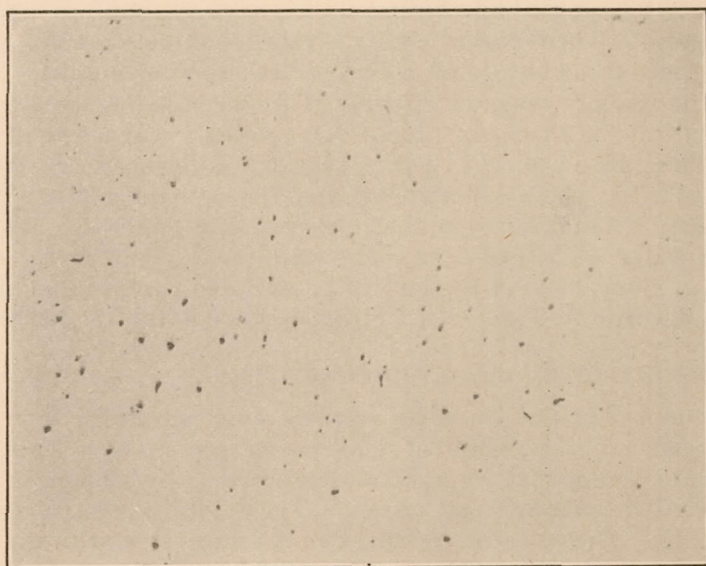
FIG. 6.—Mag. 100 \times . Microstructure of an alloy which was completely disintegrated in a few days

Figure 6 shows the structure of an alloy which corroded rapidly and was completely disintegrated by salt water. It is more nearly homogeneous than the resistant alloy shown in Figure 5. The same hard particles are present but no appreciable amount of silicide was observed.

Silicide was not responsible for the inhibitive effect, as alloys having a microstructure almost identical with Figure 6 were also quite resistant.

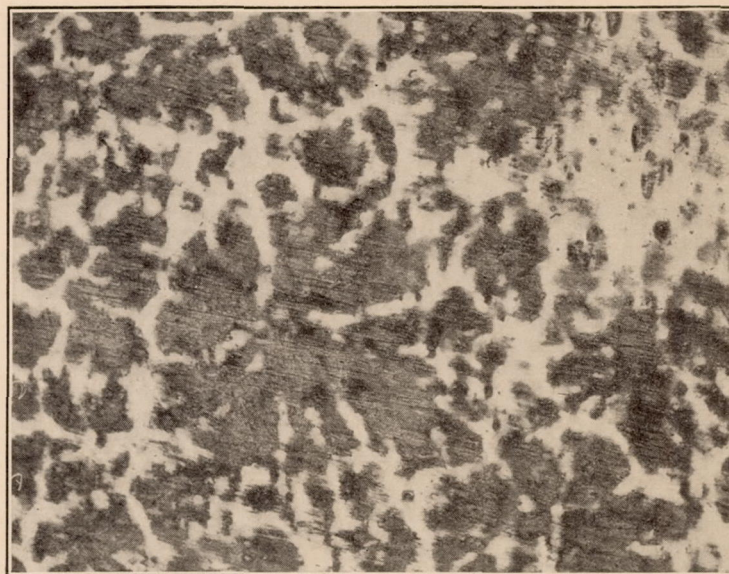
FIG. 7.—Mag. 100 \times . Tarnish pattern on polished surface of magnesium-aluminum alloy after immersion in salt water

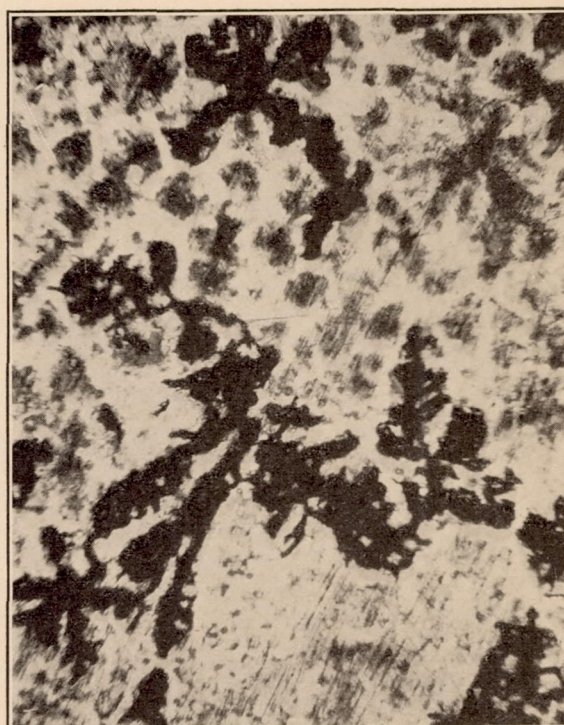
FIG. 8.—Mag. 100 \times . Showing how corrosion pits follow the tarnish pattern. Note the two hexagonal stars, upper left corner and right center

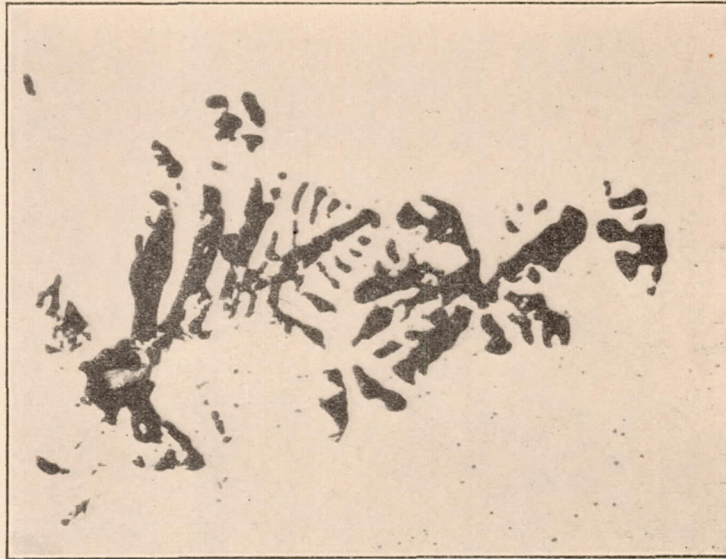
FIG. 9.—Mag. 100 \times . Dendritic corrosion pits in magnesium-aluminum alloy after repolishing

Figure 9 shows an almost perfect dendrite in a specimen which has been repolished to remove the tarnish pattern. The polishing was then carried further to see if any constituent would be found at the bottom of the pits from which hydrogen could be liberated, but none was found. A typical area is shown in Figure 10. During the eating out of the magnesium-rich dendrites both silicide and aluminum constituents were inactive, as had been previously observed in the formation of the tarnish pattern.

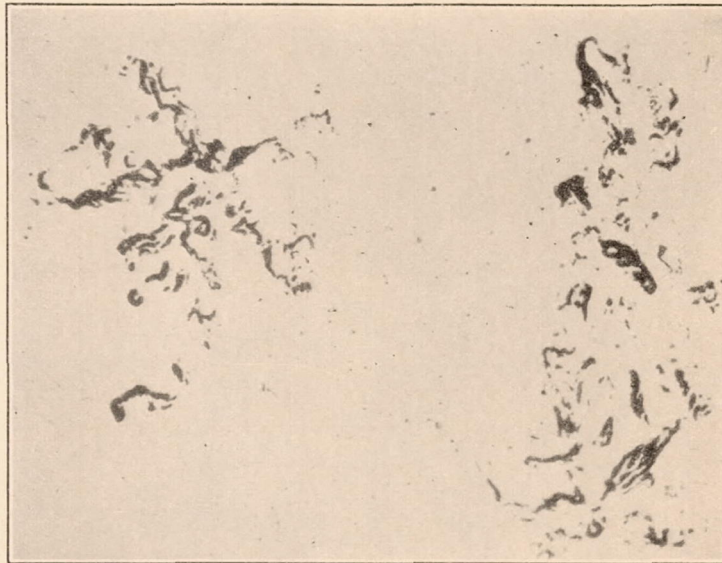
FIG. 10.—Mag. 100 \times . Bottom of corrosion pits in a 3 per cent aluminum alloy showing the absence of undissolved constituent or segregated impurity

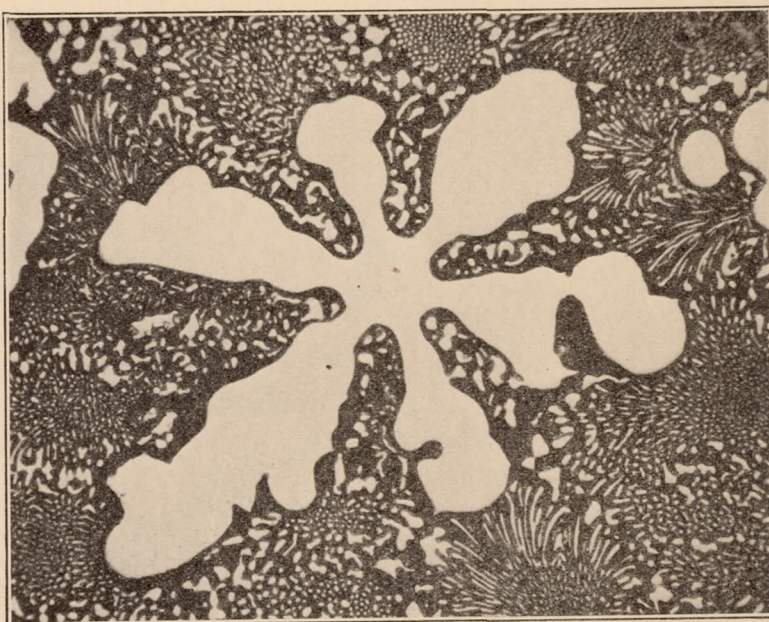
FIG. 11.—Mag. 100 \times . Primary magnesium dendrite in an alloy containing 30 per cent aluminum

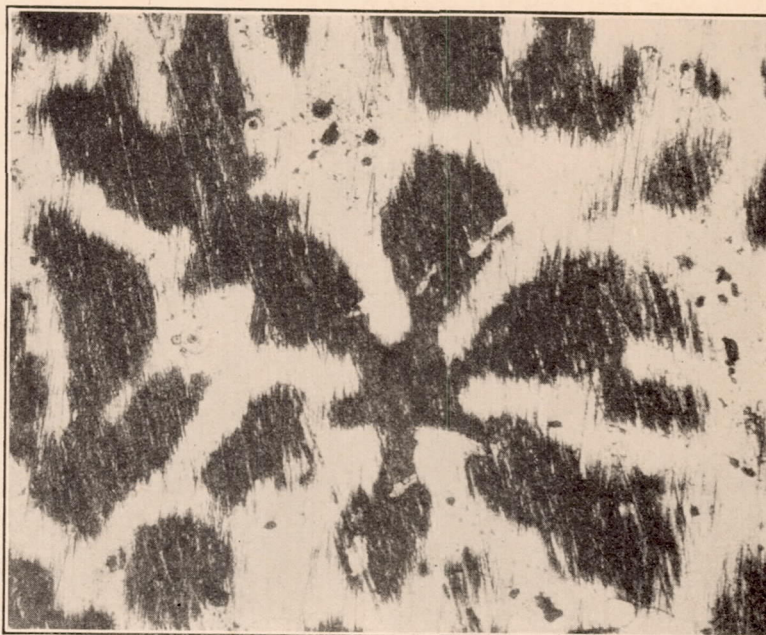
FIG. 13.—Mag. 100 \times . Tarnish pattern on polished surface of solid solution alloy (3 per cent aluminum) after immersion in salt water. Compare with Figure 11

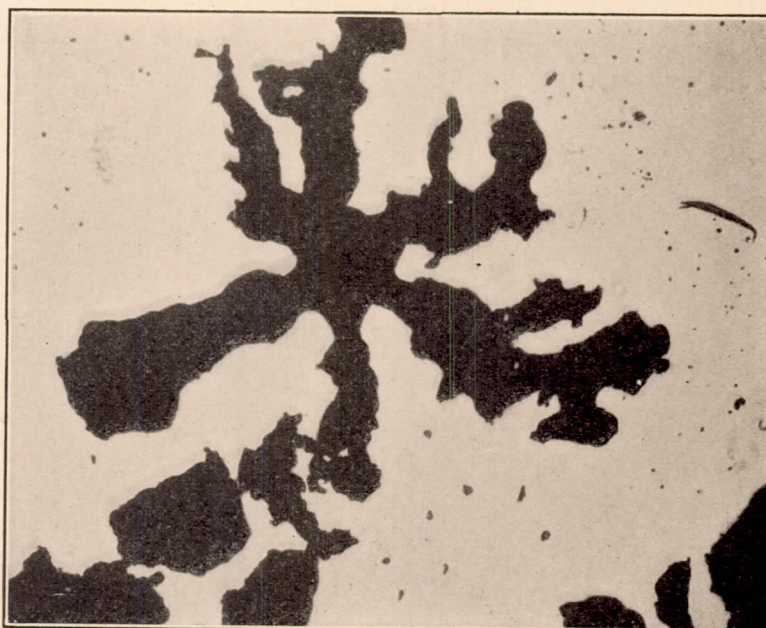
FIG. 14.—Mag. 100 \times . Corrosion pit in the alloy in Figure 13

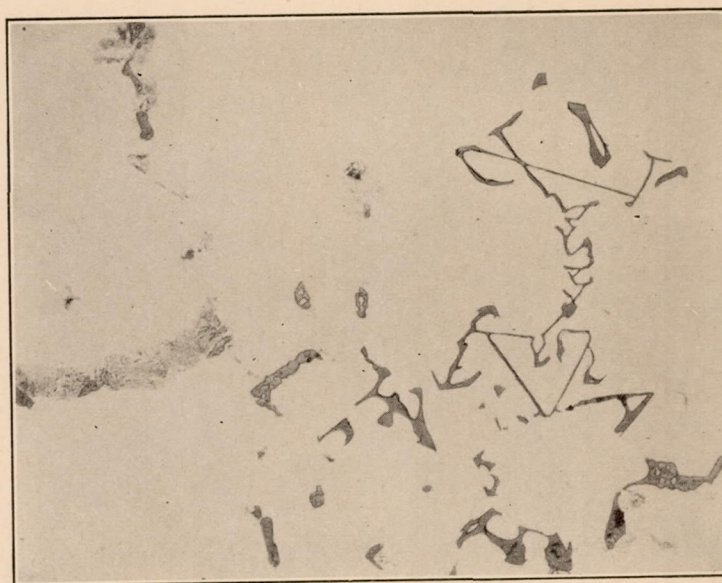
FIG. 15.—Mag. 200 \times . Microstructure of an alloy containing 5 per cent aluminum, 0.3 per cent silicon, balance magnesium

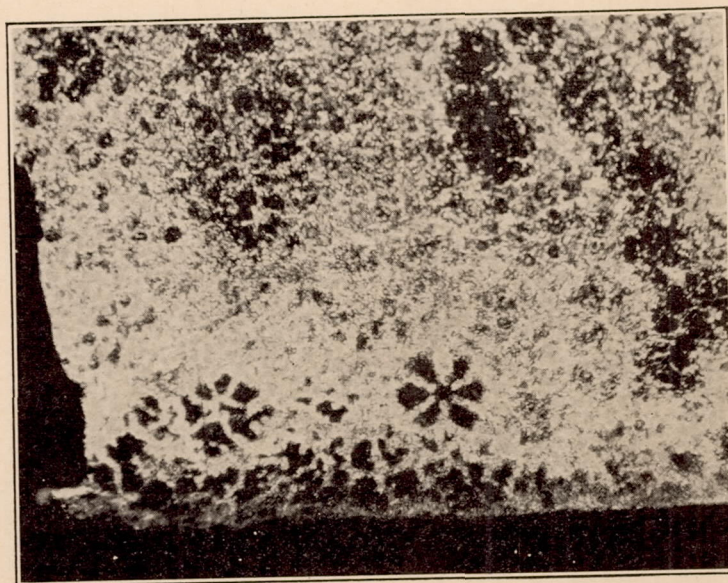
FIG. 16.—Mag. 50 \times . Cored magnesium-rich dendrite in same alloy as Figure 17, brought out by deep etching

The alloys examined in the preceding sections were practically homogeneous except for minor impurities and small amounts of undissolved constituents. Alloys having a more heterogeneous structure were next prepared to determine if any relation existed between segregation of undissolved constituents and pitting. The typical microstructure of such an alloy is shown in Figure 15. The cored magnesium-rich dendrites similar to the corrosion pits could be brought out by deep etching, as shown in Figure 16.

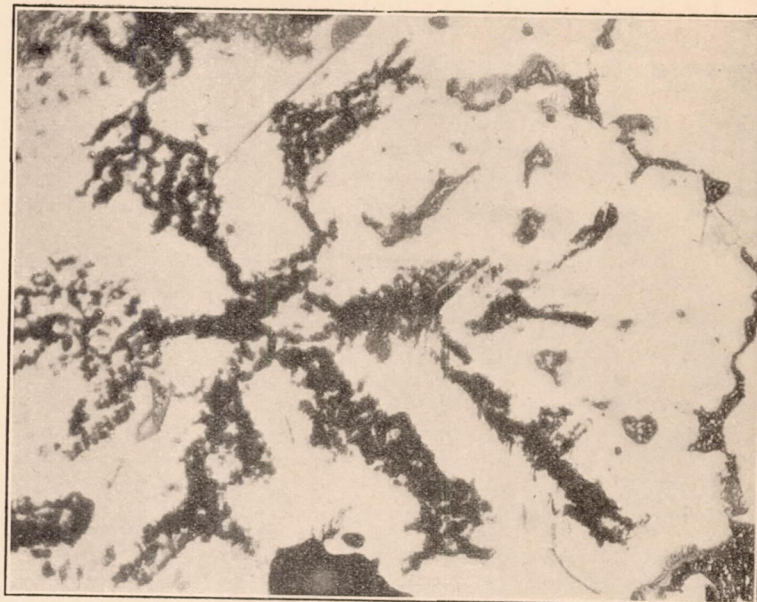
FIG. 17.—Mag. 200 \times . Corrosion pit in the alloy containing 5 per cent aluminum and 0.3 per cent silicon. The cored magnesium-rich dendrite was eaten out, while both the silicide and aluminum constituents remained inactive

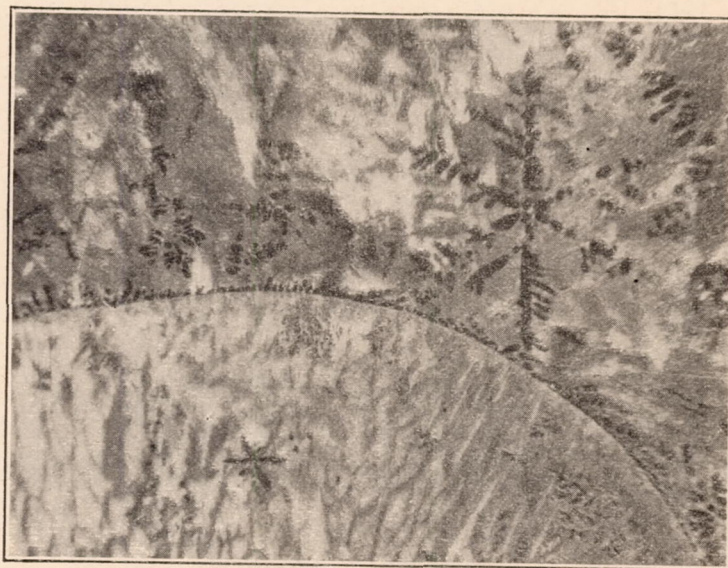
FIG. 18.—Mag. 50 \times . Primary dendrite of magnesium in an alloy containing 3 per cent silicon. Note the identical form with corrosion pit of Figure 17

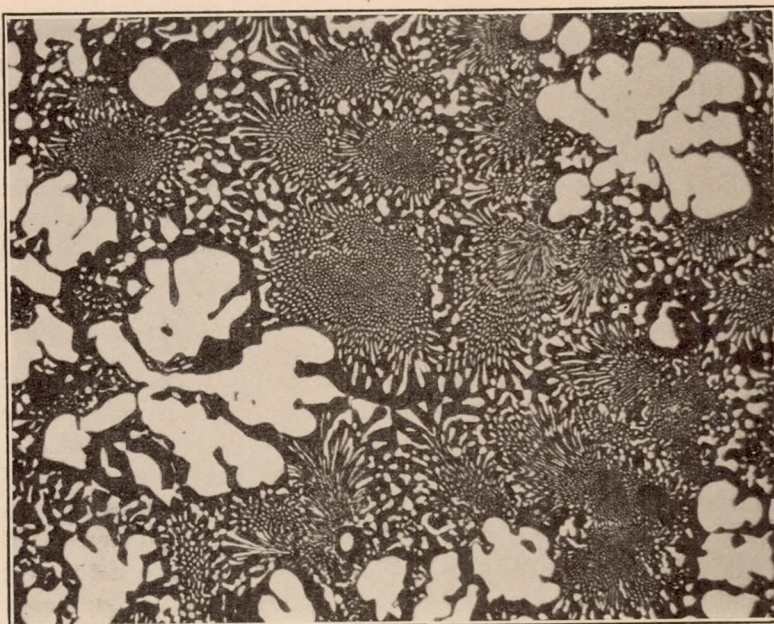
FIG. 19.—Mag. 100 \times . Primary magnesium in an alloy containing 30 per cent aluminum

When these alloys were examined while immersed in salt water the type of corrosion was found to be identical with the purer magnesium-aluminum alloys containing only one constituent. There were numerous cathode areas, but the magnesium-rich dendrites were eaten out as before and the attack was practically independent of the distribution of undissolved constituents. This is shown in Figures 17 and 20. All specimens did not show perfectly formed dendrites, but there was usually a similarity between the form of the corrosion pit and that of primary magnesium, as illustrated in Figures 19 and 20.

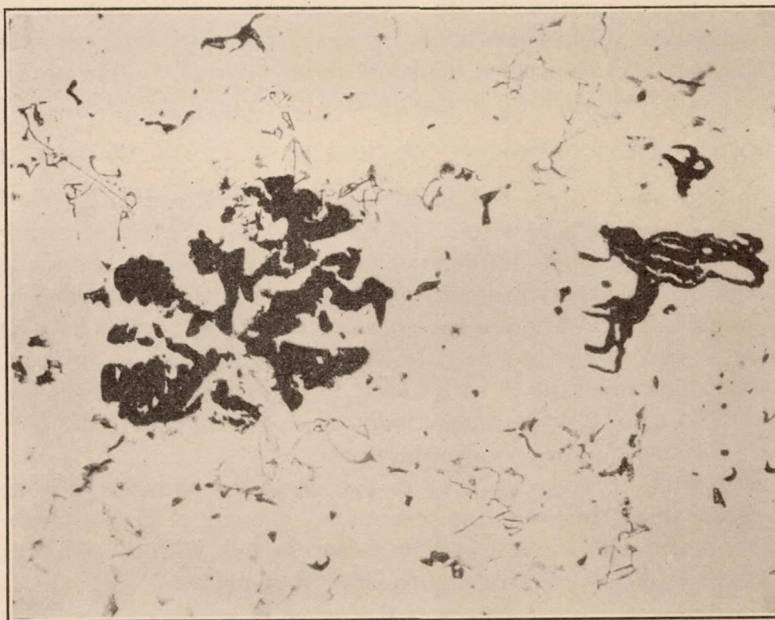
FIG. 20.—Mag. 100 \times . Corrosion pits in an alloy containing 5 per cent aluminum and 0.3 per cent silicon, showing that corrosion attack is independent of the distribution of undissolved constituents and also similarity in form of pits to primary magnesium, Figure 19

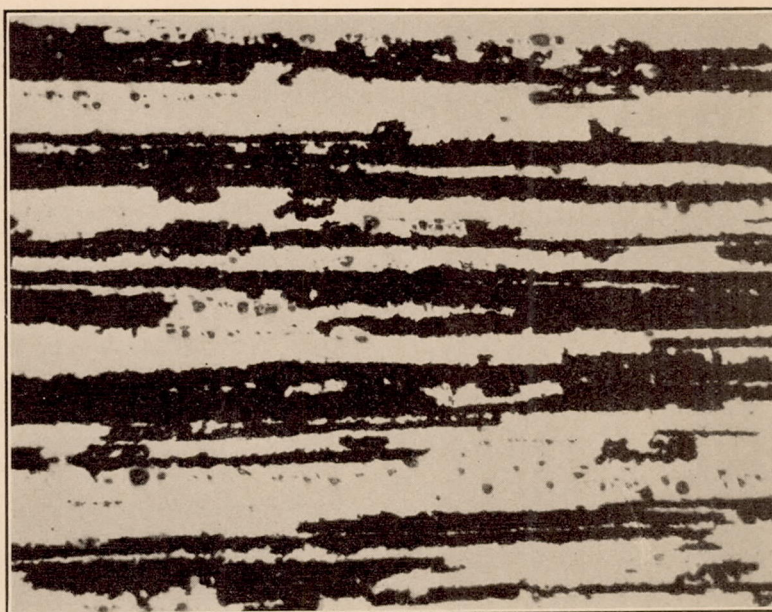
FIG. 21.—Mag. 100 X. Corrosion pits in alloy containing 4 per cent Al, 0.2 per cent Mn, extruded, longitudinal section. The cores have been drawn out into a fibrous structure

In the longitudinal section the corrosion pits were all straight lines parallel to the direction of extrusion, as shown in Figure 21. The corrosion attack of the transverse section was irregular and did not have a directional tendency. The cored areas were presumably drawn out into a more or less fibrous structure and their original dendritic form was lost.

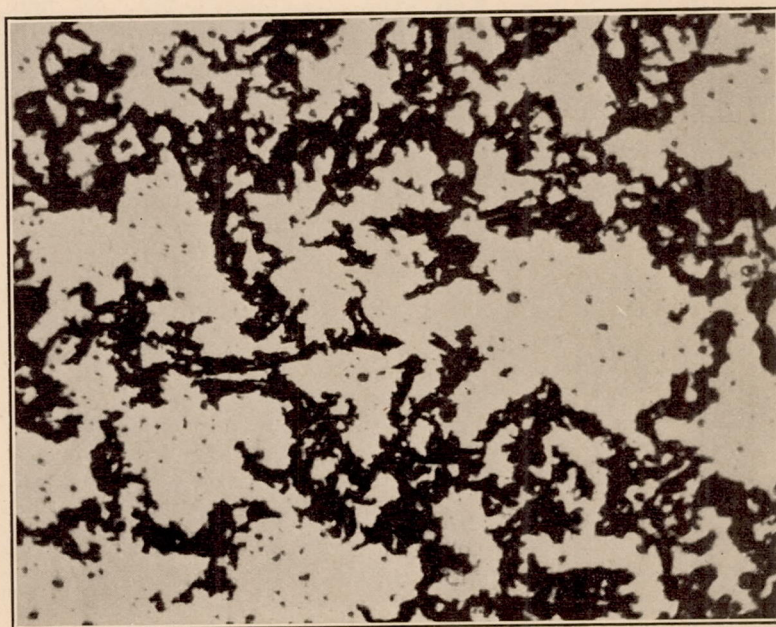
FIG. 22.—Corrosion pits in transverse section of extruded alloy. Note the absence of a directional tendency

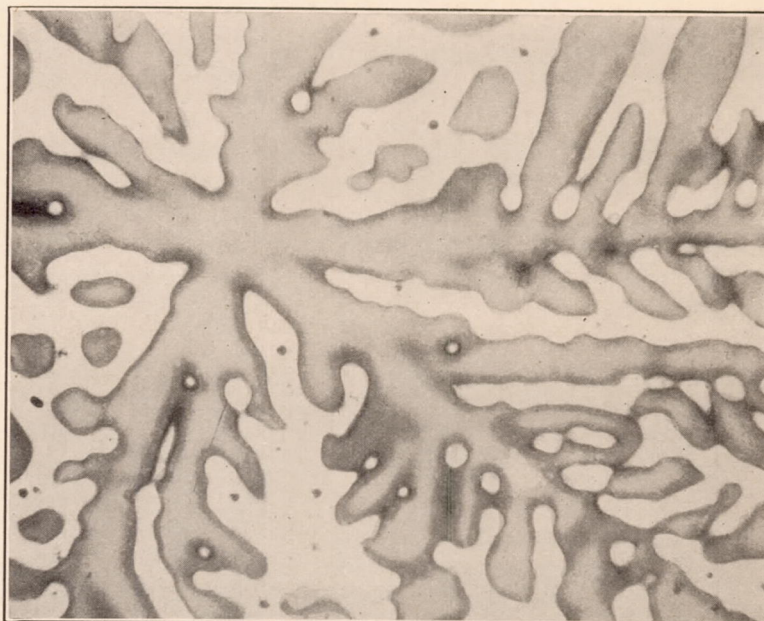
FIG. 23.—Mag. 100 X. Cored dendrite in 3 per cent aluminum alloy

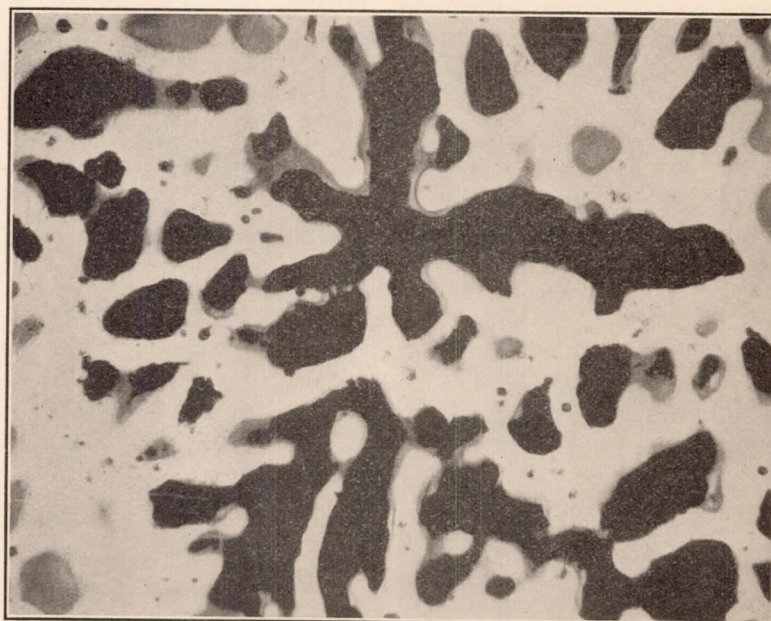
FIG. 24.—Mag. 100 X. Corrosion pits in the alloy of Figure 23. Specimen was repolished and etched after corrosion. Corrosion pits black; cored dendrites halftone

When the specimens which had been corroded in salt water and then repolished to remove the tarnish film were etched to bring out the cored structure it was found that the corrosion pits were superimposed on the magnesium-rich cores, as shown in Figure 24.

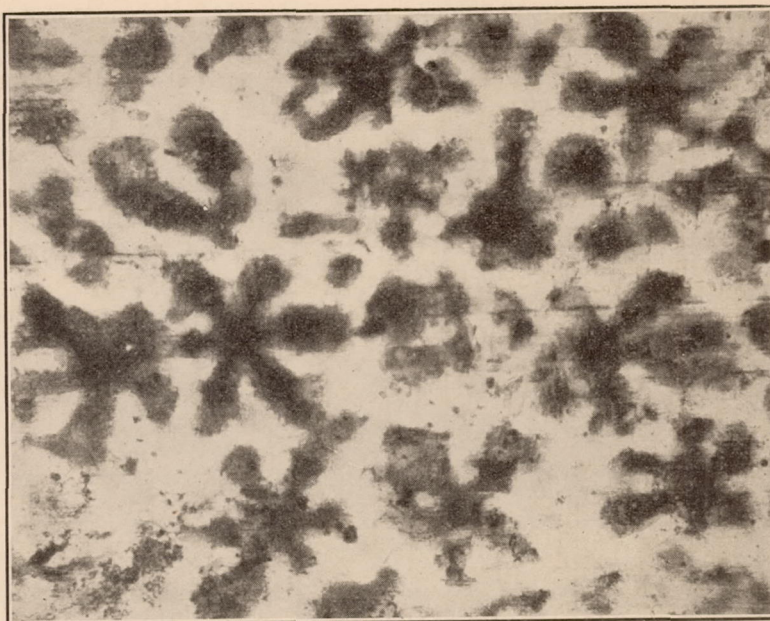
FIG. 25.—Mag. 100 \times . Tarnish pattern of magnesium-aluminum alloy containing 0.3 per cent manganese

The tarnish pattern brought out by the action of salt water showed that manganese did not change the dendritic structure of the magnesium-aluminum alloys (fig. 25). The type of corrosion was similar to that of the binary alloys without manganese, except that the tarnished dendrites did not have as great a tendency to be eaten out. The cored structure would also be developed by etching, as shown in Figure 26.

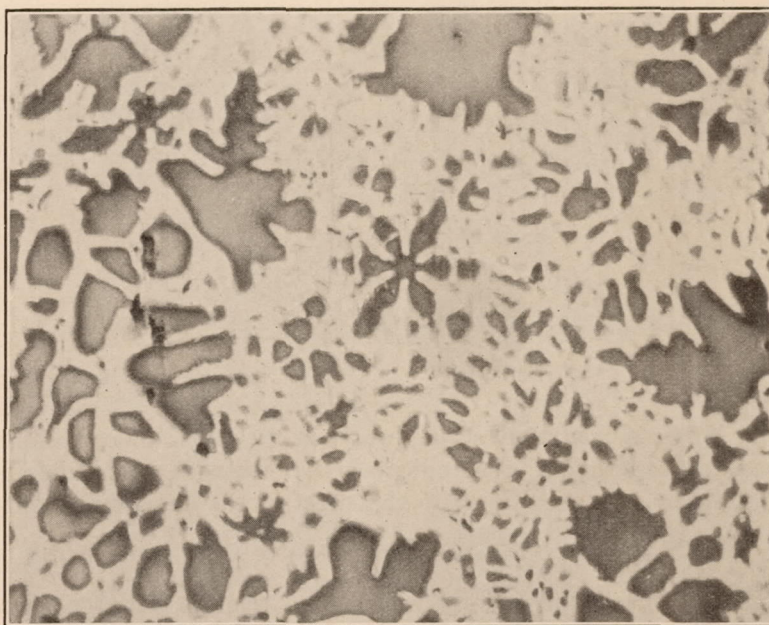
FIG. 26.—Mag. 100 \times . Cored structure of magnesium-aluminum alloy containing 0.3 per cent manganese

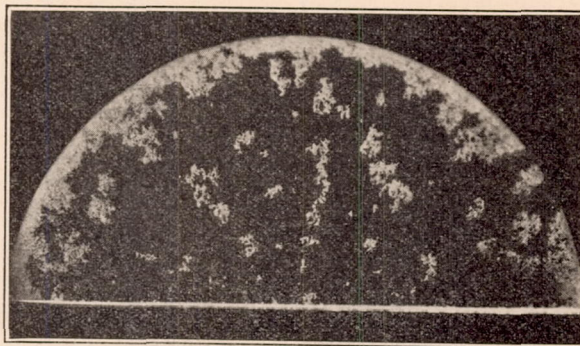
FIG. 27.—Corrosion of chill cast magnesium-aluminum alloy containing 0.2 per cent Mn

On polishing a cross-section of half the ingot, it was found that chill casting had a marked effect on the distribution of the corrosion attack. The corroded specimen is shown in Figure 27. The specimen is slightly reduced in size and is shown by oblique illumination; the corroded areas appear light and the polished surface dark. The area around the chilled edge is corroded almost uniformly to an extent of about half an inch; the cut edge, which shows as a heavy

white line because it catches the oblique illumination, is not pitted at all. Here again is a reproduction on a large scale of the corrosion attack observed microscopically; the first part of the alloy to solidify, in one case the chilled edge and in the other case the cored dendrite, is attacked preferentially and this attack is practically independent of the distribution of metallic constituents or nonmetallic inclusions. A sand-cast specimen, corroded at the same time for comparison, was uniformly pitted (fig. 29).

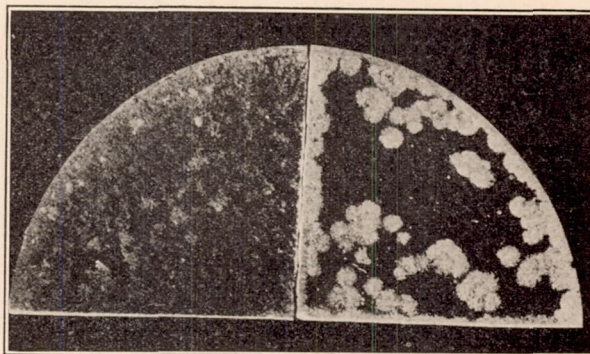
FIG. 28.—Same specimen as Figure 27. Left half as cast; right half annealed five days at 400° C.

Figure 28 shows the two halves of the specimen, the left half as cast and the right half annealed for five days at 400° C. In the heat-treated specimen the dendritic attack, running from the outer edge in tree-like fashion, was absent but it appeared that whole grains were eaten out. Resistance to corrosion was not bettered. When extruded pieces of the same alloy were given a similar heat treatment and tested quantitatively for corrosion they were found to even be worse than before heat treatment.

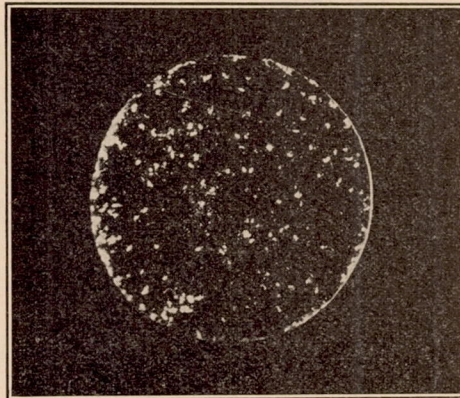
FIG. 29.—Corrosion pits in polished specimen of sand cast alloy containing 0.4 per cent manganese

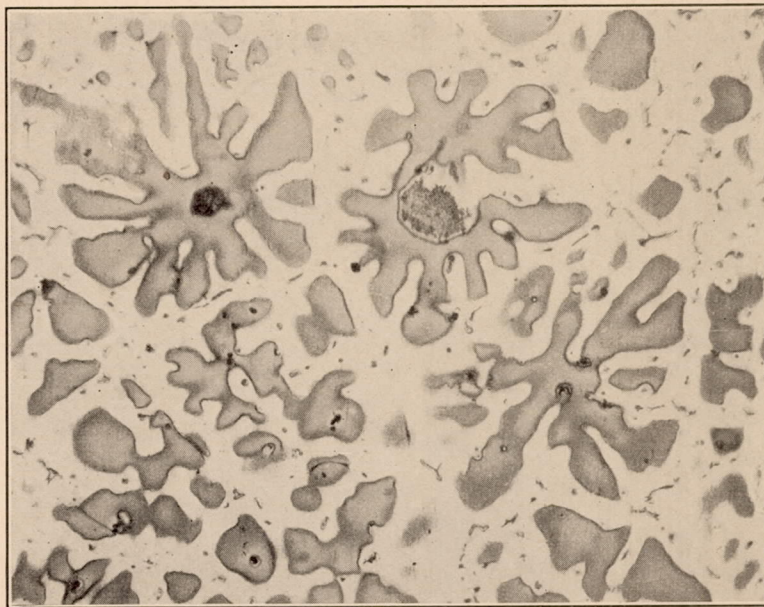
FIG. 30.—Mag. 100 X. Cored magnesium-rich dendrites surrounding nonmetallic inclusions

Etching to develop cored structure showed that the relation between films and inclusions and corrosion was only apparent. The inclusions act as nuclei for the solidification of the magnesium-rich cored centrites, as shown in Figure 30. As the inclusion becomes larger the

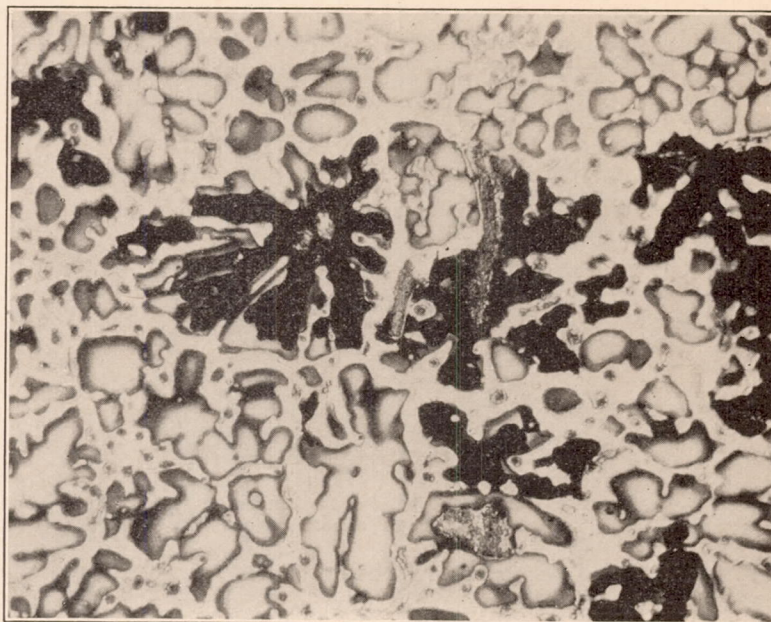
FIG. 31.—Mag. 100 \times . Corrosion in area containing inclusions, showing relation between pitting and cored structure

dendrite loses its symmetry and tends to branch out at right angles from the edge of the inclusion to which it is attached. When the specimen is immersed in salt water the magnesium-rich cores are attacked, leaving the inclusion surrounded by a corrosion pit. This type of corrosive action is illustrated in Figure 31.

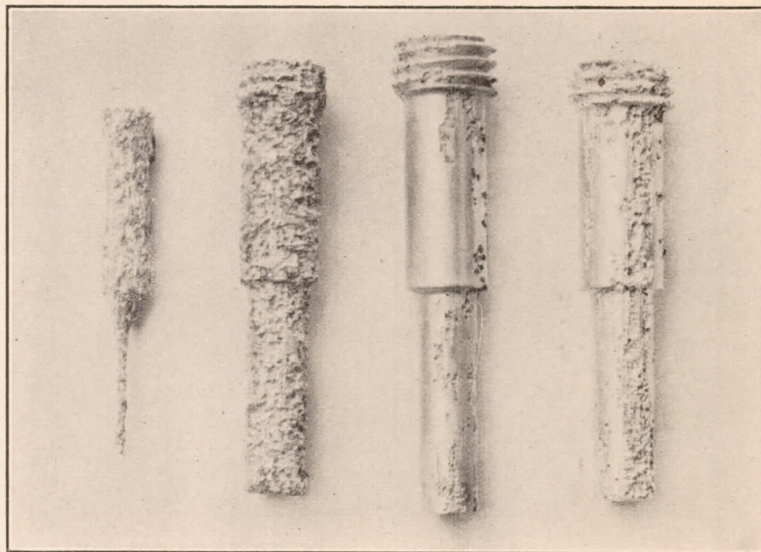
FIG. 32.—Effect of varying the manganese content of the 4 per cent aluminum alloy
 1. 0.10 per cent Mn
 2. 0.22 per cent Mn
 3. 0.36 per cent Mn
 4. 0.66 per cent Mn
 All as extruded; five days' immersion, 2 per cent NaCl solution

A series of corrosion tests was made to determine the effect on corrosion of varying the manganese content of the 4 per cent aluminum alloy. The specimens were test bars which had been previously broken in tensile tests, and were machined to present a clean surface. A 2 per cent sodium chloride solution was used, and the results after five days' immersion are shown in Figure 32.

It is evident from these tests that a critical amount of manganese is necessary to produce a maximum inhibiting effect. The alloys low in manganese were badly corroded. A few hundredths of a per cent will make all the difference between an alloy which corrodes rapidly and one which is resistant. In order to determine more accurately the effect of small variations, a series of alloys was made in which the manganese was varied by approximately .05 per cent intervals. The specimens were the standard corrosion test pieces, $3 \times 1\frac{1}{8}$ inches $\times \frac{3}{16}$ inch. After five days' immersion in 2 per cent sodium chloride solution the pieces were acid cleaned and weighed.

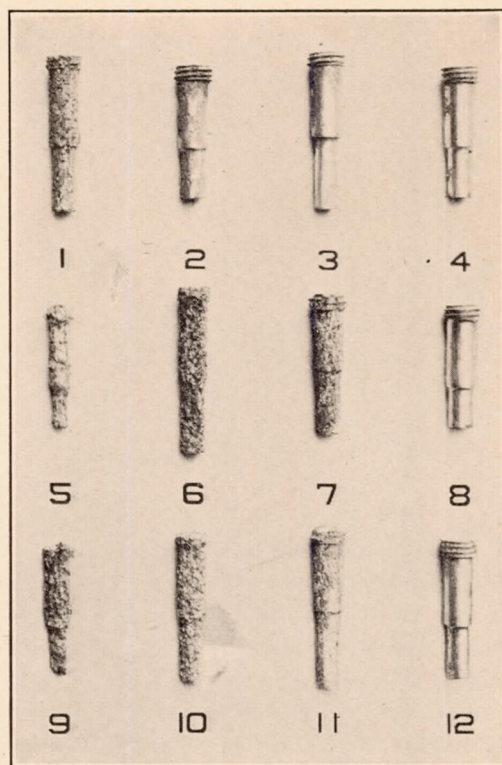
FIG. 33.—Corrosion tests of 6 per cent aluminum alloy containing varying amounts of manganese.

Spec. No.	Al	Mn
1	6.18	0.10
2	6.60	.20
3	5.91	.35
4	6.1	.57

The photographs of the 6 and 8 per cent series show the extent to which corrosion was inhibited in the specimens containing sufficient manganese. The effect is not brought out as well in the 12 per cent series because the latter are turned black on acid cleaning and do not present a polished surface. On visual examination after corrosion the 12 per cent alloy specimens 6, 12, and 18 were found to be unattacked by salt water except for a black surface discoloration.

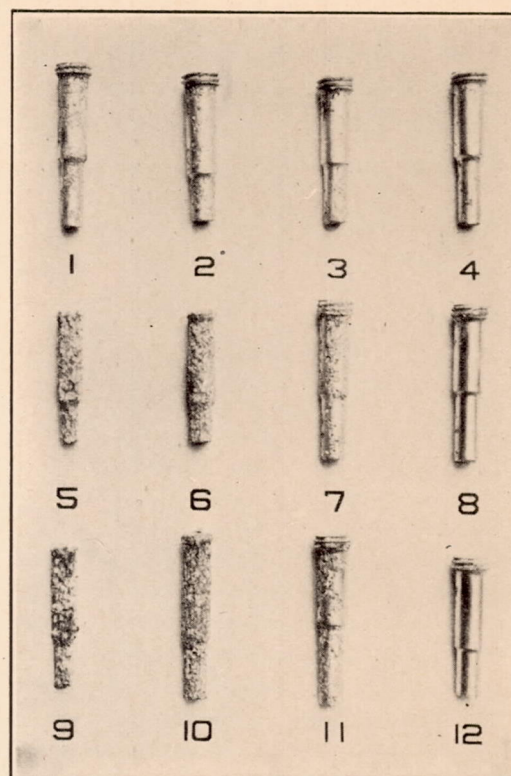
FIG. 34.—Corrosion tests of 8 per cent aluminum alloy containing varying amounts of manganese

Spec. No.	Al	Mn
1	8.61	0.12
2	7.86	.17
3	8.49	.42
4	8.18	.55

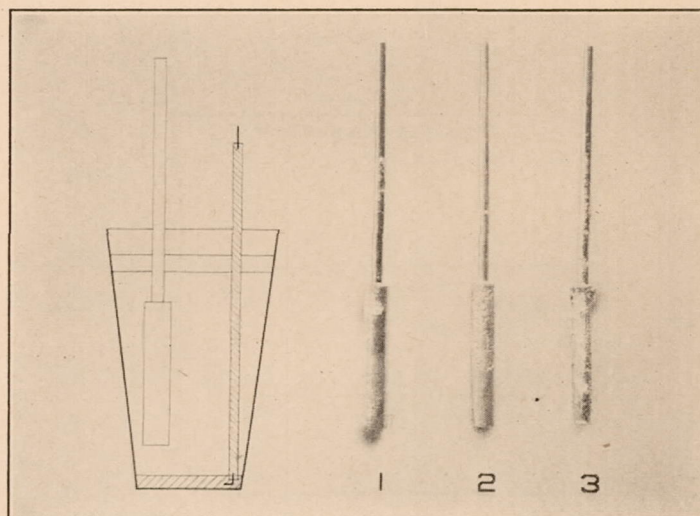
FIG. 36.—Electrolytic cell and electrodes used in overvoltage experiment. (1) Immersed in 10 per cent NaCl solution 7 days. (2) Connected to mercury 48 hours. (3) Connected to platinum 48 hours

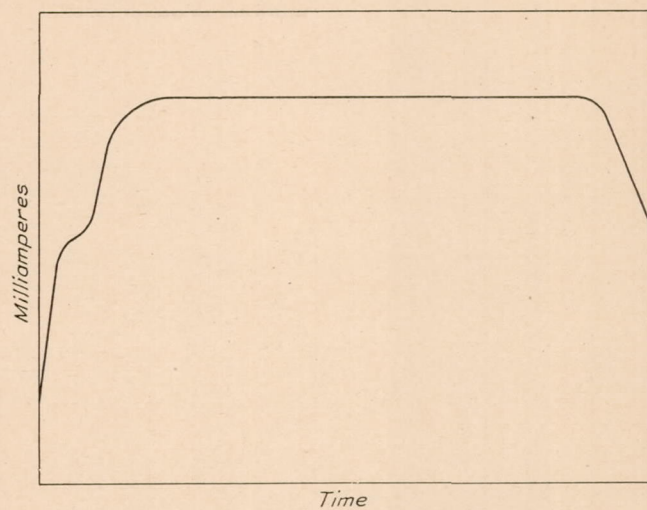
FIG. 37.—Current. Time curve for electrode connected to platinum

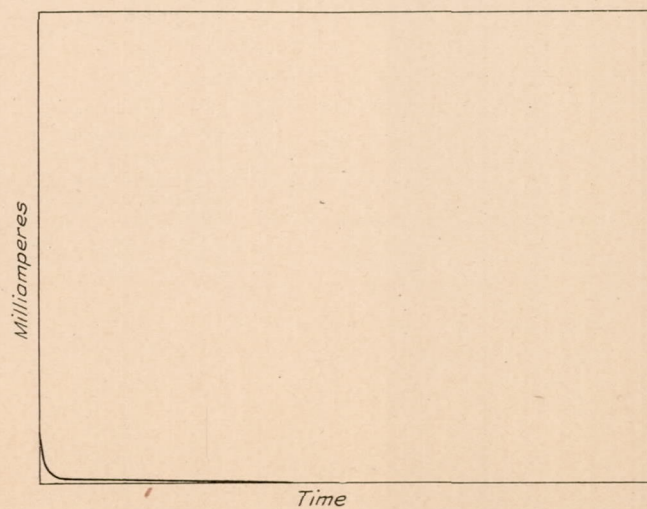
FIG. 38.—Current. Time curve for electrode connected to mercury

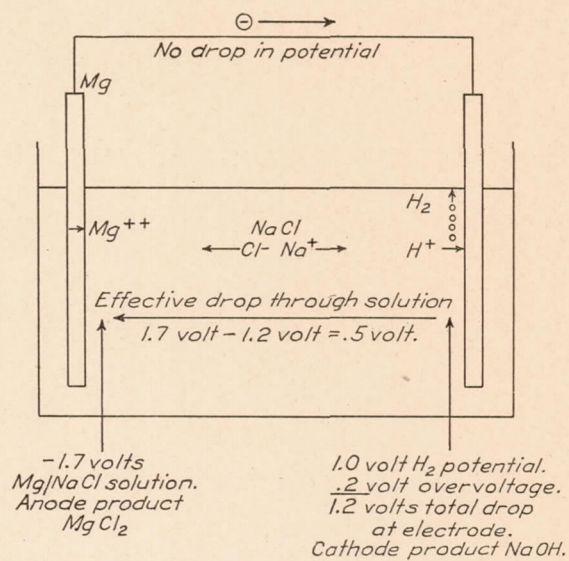
FIG. 39.—Diagrammatic representation of galvanic action with impurity of low overvoltage

The electrolytic corrosion cell is short circuited and there is practically no drop in potential through the metal. Thus the second metal or impurity tends to assume practically the same high potential as the magnesium. However, if the overvoltage is low, it can not keep this potential with respect to the solution, for hydrogen will plate out before the potential can be built up to this value. The impurity then functions not as a metal electrode but as a hydrogen electrode. If the impurity has no overvoltage it assumes practically the true hydrogen potential. If it has approximately two-tenths volt overvoltage it will assume a potential two-tenths volt higher than this. If the overvoltage equals or is greater than that of the reactive metal no current will flow unless the potential of the reactive metal is high enough to displace hydrogen on its own surface. Under any condition there is only a few tenths of a volt difference in *effective* potential between magnesium and the impurity. This effective potential difference may even be zero, whereas the difference in potential on open circuit may be from one to two volts.

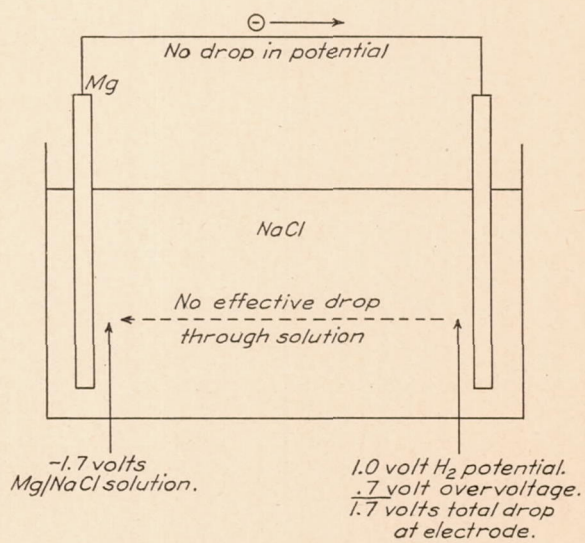
FIG. 40.—Diagrammatic representation of galvanic action with impurity of high overvoltage
